# **Plutonium Intakes at the Savannah River Site FB-Line on September 1, 1999**

**Chuck Radford, DOE-SR  
Tony Weadock, EH-10**

**Subject: Pu-239 Release/Worker Intakes**

**Contractor: Westinghouse Savannah River Company**

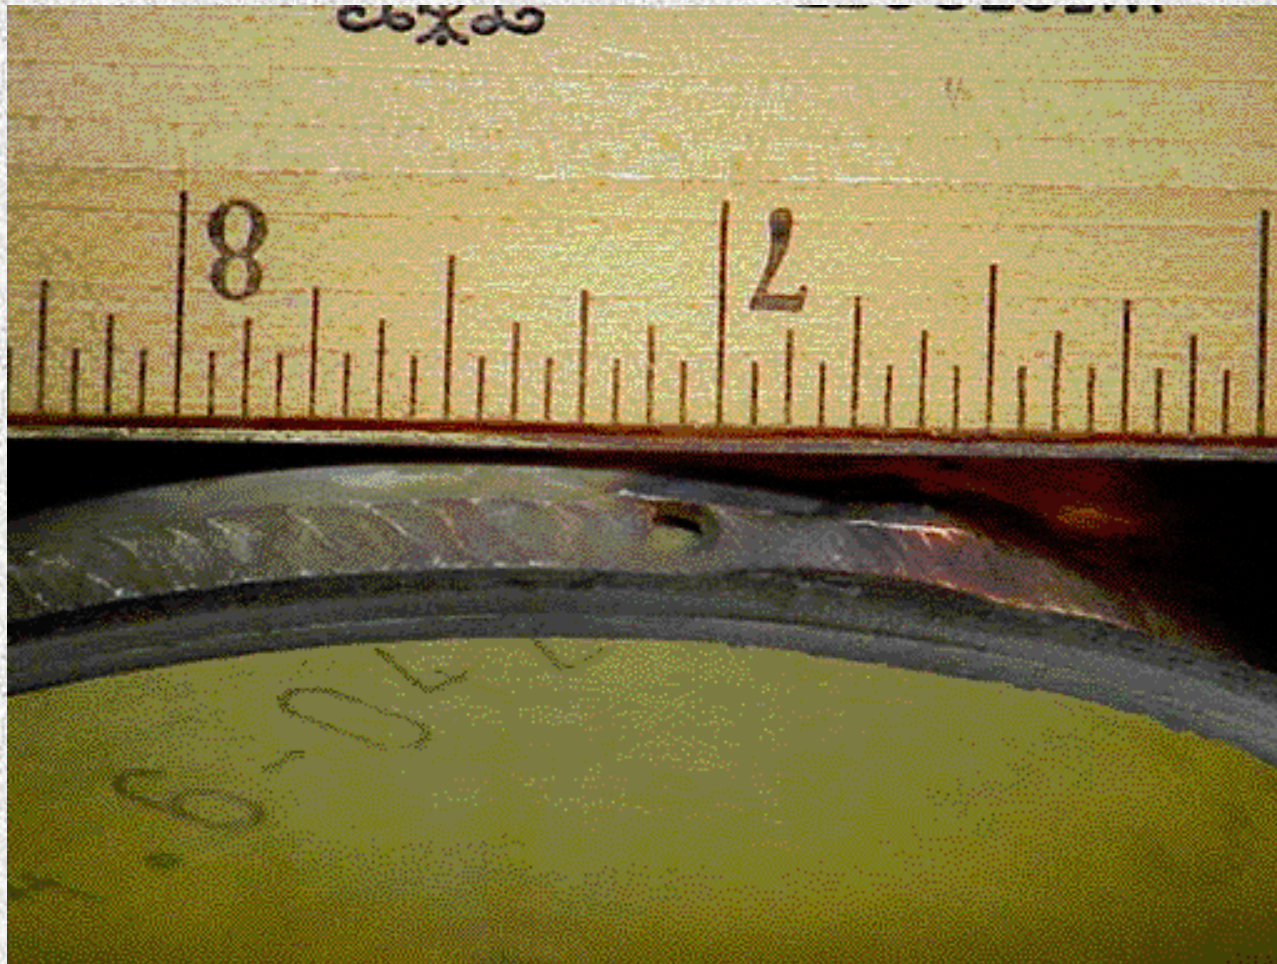
# Picture of Failed Bagless Transfer Can

- ◆ **Hole in weld existed at completion of weld.**
- ◆ **Oval-shaped hole with ~0.1 inch diameter in can weld at second tack weld.**
- ◆ **A lump of excess material was adjacent to hole.**
- ◆ **No deviations from specifications found in canister chemical composition, dimensions or cleanliness.**
- ◆ **Appearance of weld hole consistent with blow-out during welding.**
- ◆ **SRTC could not conclusively determine exact cause of weld failure.**
- ◆ **Most likely cause – overpressurization of can during welding (possibly due to lack of venting).**
